| | GROUP BOD | MODEL 2016-2017MY Optima (JFa) |
| | NUMBER 300 | DATE March 2021 |
| TECHNICAL SERVICE BULLETIN | | |
| SUBJECT: WINDOW REGULATOR DRUM GEAR REPLACEMENT | | |

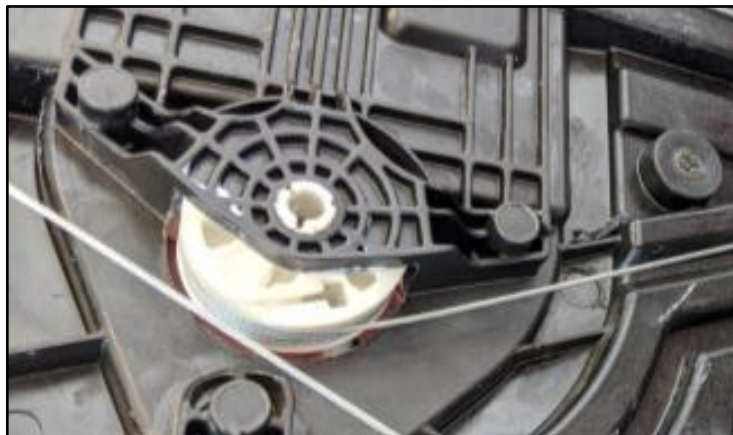
This bulletin provides the procedure to replace the window regulator drum gear on some 2016-2017MY Optima (JFa) vehicles, produced from September 01, 2015 through July 31, 2016, which may exhibit an inoperative window regulator due to a drum gear separating and/or breaking. To correct this concern, follow the procedure outlined in this bulletin to install the improved drum gear to the affected window regulator.

Window Regulator Drum Gear

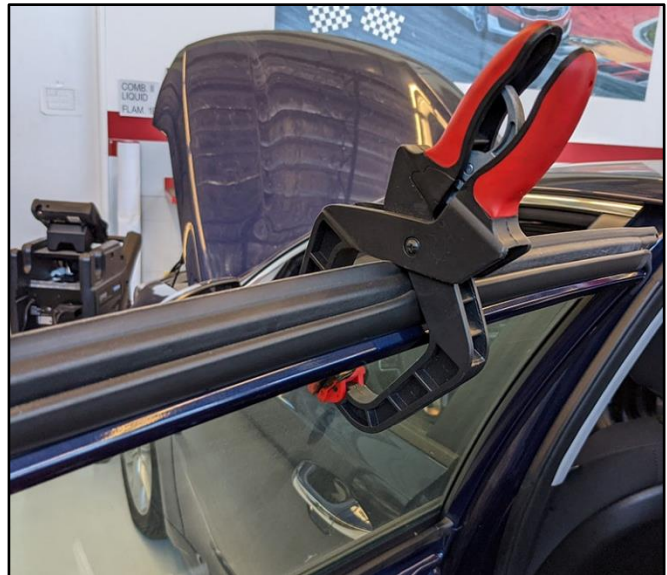
- 5b. Hold the door window glass securely in place using tape or rubber padded clamp.

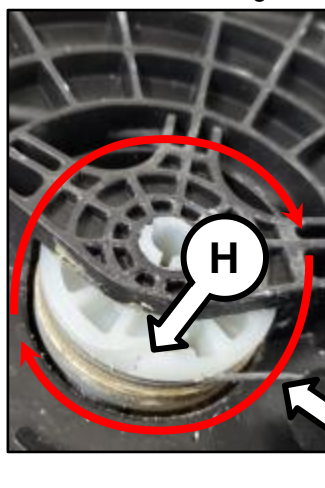
9. Turn the drum gear (H) to wind the lower wire cable (G) to the drum gear in the specified direction:

- Front Left & Rear Right Door: Turn **clockwise**.
- Front Right & Rear Left Door: Turn **counterclockwise**.

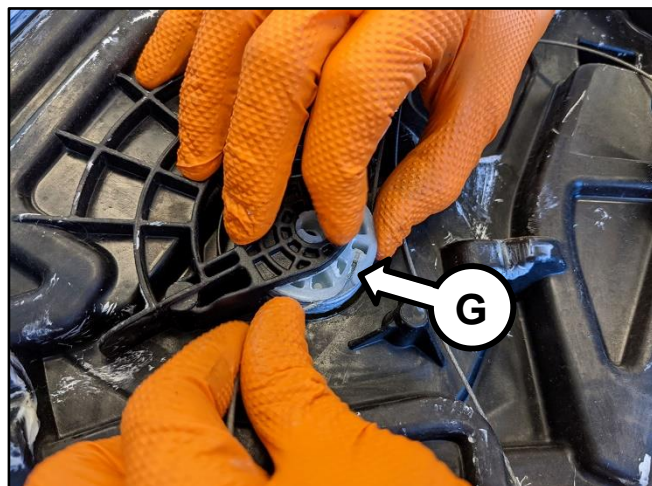
10. While holding on to the drum gear, insert and attach the upper wire cable (G) onto the drum gear (H).

Turn the drum gear (H) several times until slack within the wire cable (G) is removed.

- Front Left & Rear Right Door: Turn **clockwise**.
- Front Right & Rear Left Door: Turn **counterclockwise**.

Be careful not to unwind the lower wire cable.

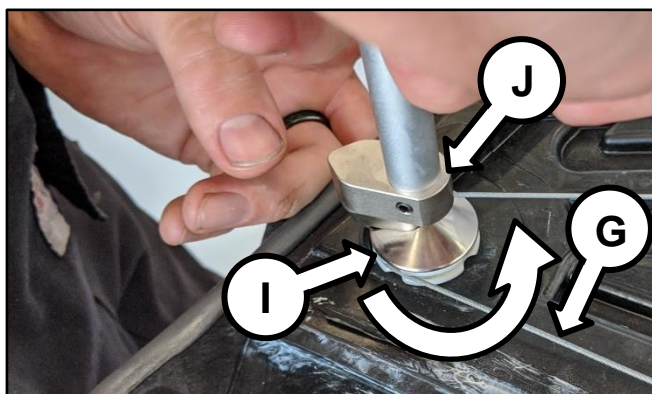
14. Turn the SST (J) counterclockwise to loop the wire cable (G) onto the pulley (I).

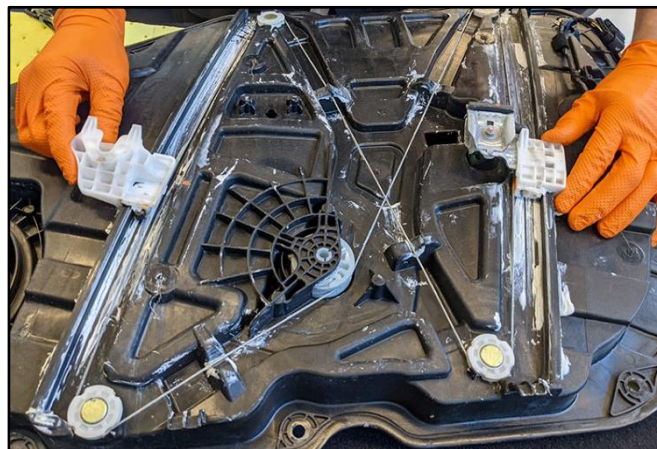
16. Slide the tracking system (K) back and forth to confirm that the wire cable is engaged and winding as designed.
